Analysing Surface Deformation in Surabaya from Sentinel-1A Data using DInSAR Method

Ira M. Anjasmara, Meiriska Yusfania, Akbar Kurniawan, Roni Kurniawan, Awalina L C Resmi

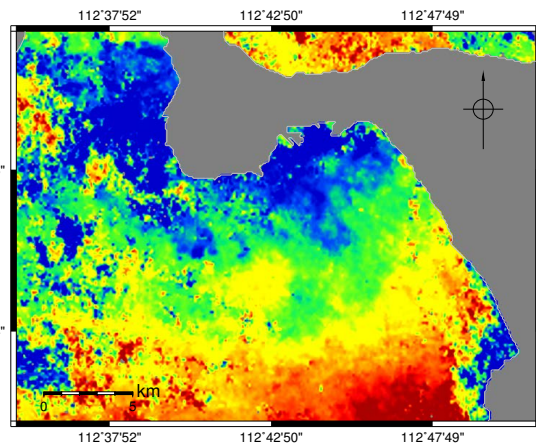
May 2015 – Sept 2015

Max: 70.45 mm
 Min: - 58.57 mm
 Mean: 2.35 mm
 Std: 16.42 mm
 RMS: 16.58 mm

- The surface deformation in Surabaya occurs in the form of subsidence and uplift .
- Comparison with other studies shows that the pattern of surface deformation is not very clear. But it can be confirmed that the coastal area of Surabaya suffer from subsidence more than other areas.
- The average rate of deformation from May 2015 to September 2016 is varies from $-3.52\text{mm}/4\text{months}$ to $+2.35\text{ mm}/4\text{months}$

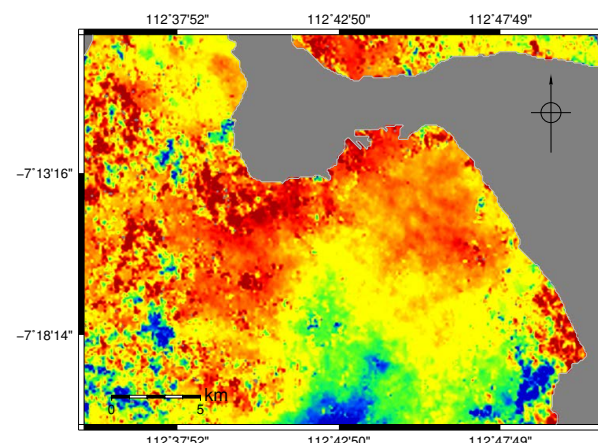
Sept 2015 – Jan 2016

Max: 59.49 mm
 Min: - 51.89 mm
 Mean: - 3.52 mm
 Std: 11.79 mm
 RMS: 12.31 mm

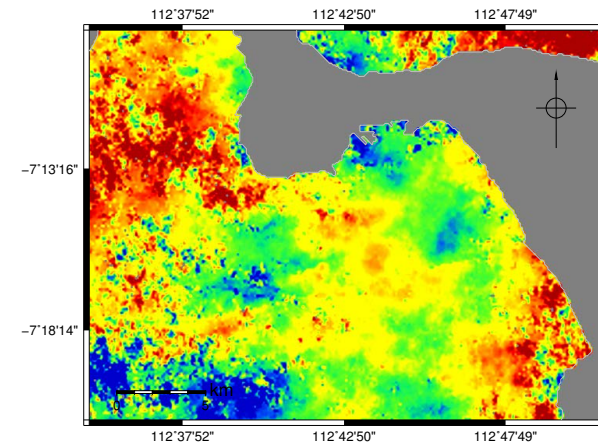
Jan 2016 – May 2016

Max: 74.21 mm
 Min: - 71.33 mm
 Mean: 1.54 mm
 Std: 14.21 mm
 RMS: 14.29 mm

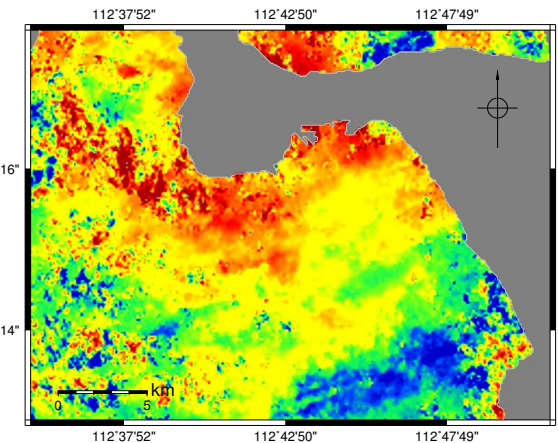
May 2016 – Sept 2016

Max: 50.10 mm
 Min: - 57.47 mm
 Mean: 0.89 mm
 Std: 12.22 mm
 RMS: 12.25 mm

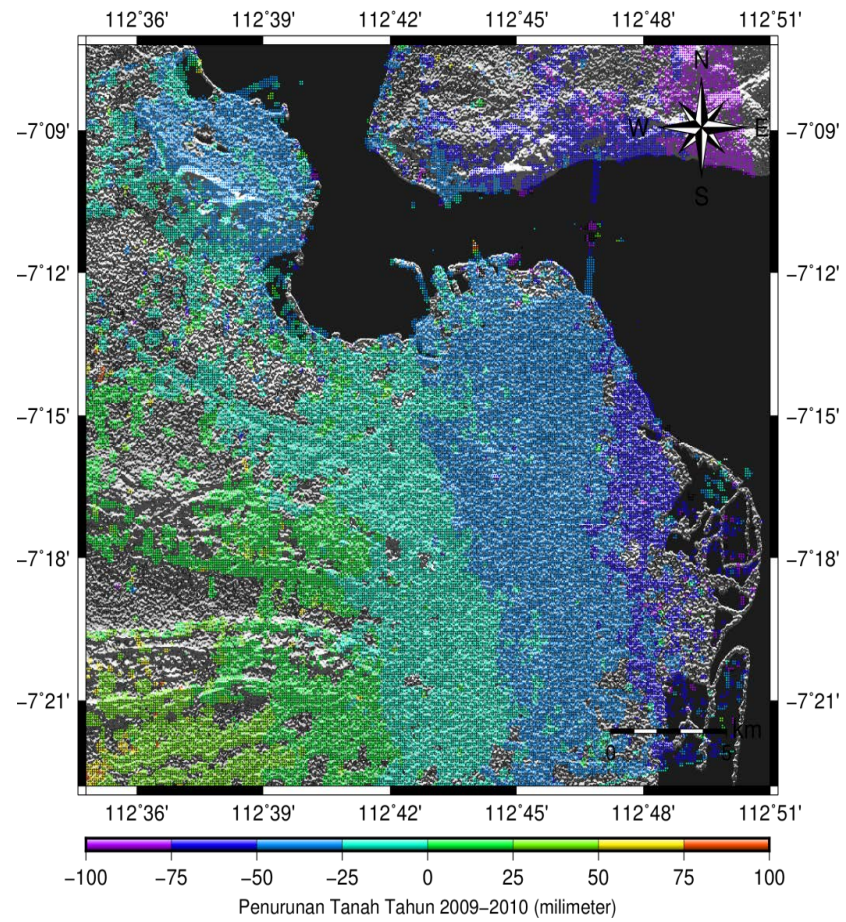
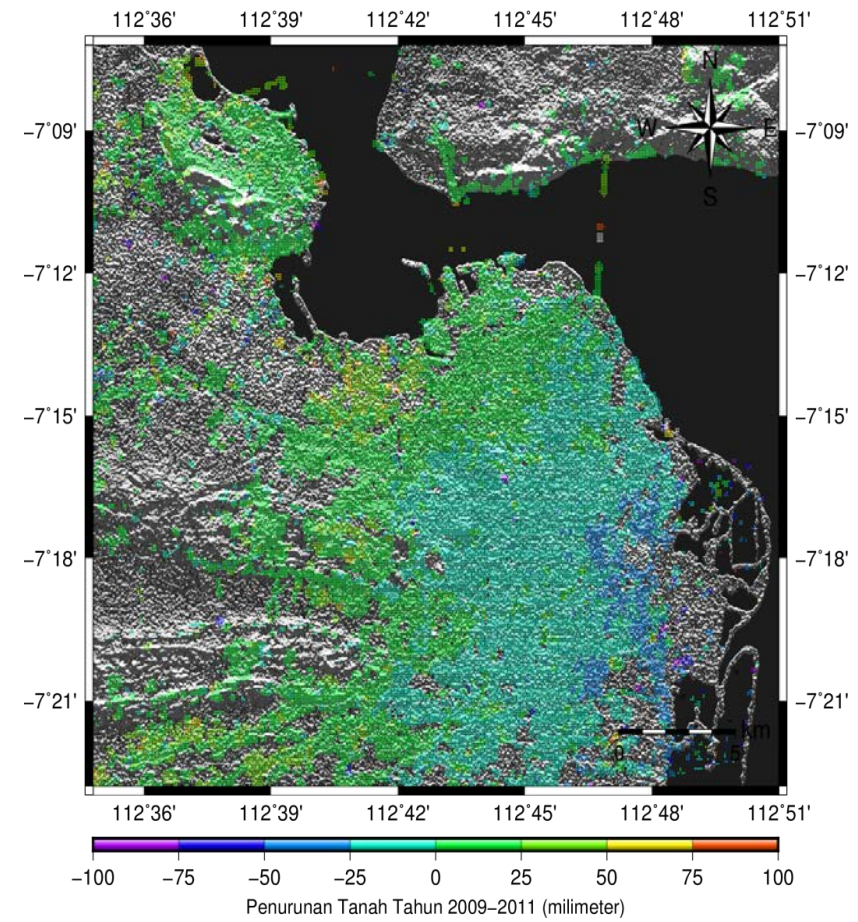
Hasil *Land Subsidence* dari data ALOS PALSAR tahun 2009-2011 (Resmi et al, 2016)

Sample point	Location	Handoko et al, 2011 (GPS measurement)	Resmi et al, 2016 (DInSAR ALOS PALSAR)	This research (DInSAR Sentinel-1A)			
		2007-2010	2009-2011	052015-092015	092015-012016	012016-052016	052016-092016
		Vertical displacement (mm)	LOS displacement (mm)	LOS displacement (mm)			
1	Rungkut	-70.53	-51.55	-14.42	1.84	4.84	18.16
2	Kota	-46.54	-50.77	0.72	10.74	-6.73	6.15
3	ITS	30.54	25.01	0.75	-2.46	3.88	3.55
4	Waru	-5.99	-15.14	-14.16	14.17	5.39	19.45
5	Sby Barat	-0.64	-1.61	10.92	-9.33	-0.11	4.53
6	Kenjeran	4.94	24.28	22.28	-14.53	-1.76	-4.84
7	Kalianak	11.96	4.29	10.51	-5.52	-0.39	-5.23
8	Pasarturi	13.22	14.18	20.12	-6.38	-4.22	1.27
